## *just the* **FACTs**

## **Herbert Hoover Dike Analysis Report Findings and Recommendations**

# Lake Okeechobee Flood Control System

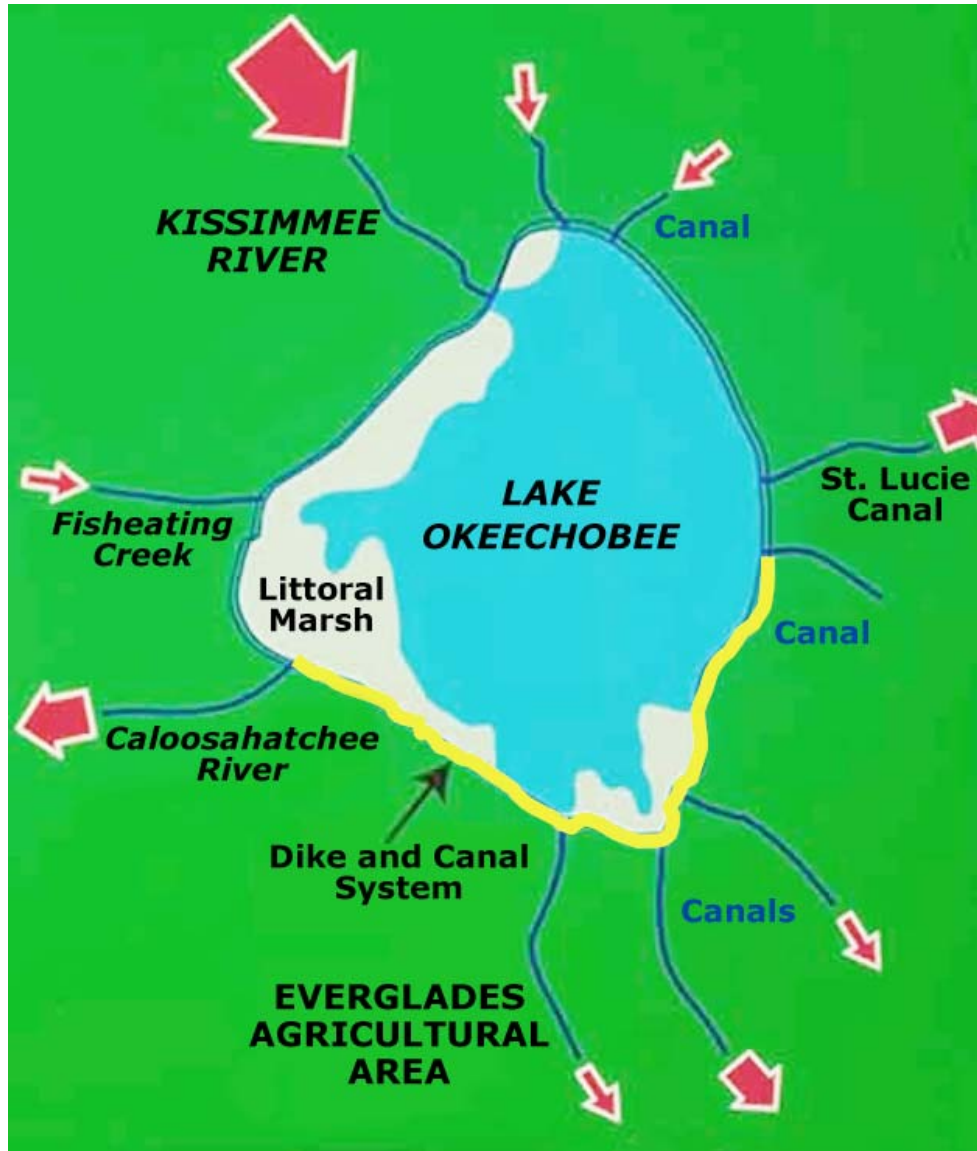
The **Herbert Hoover Dike** surrounds Lake Okeechobee, spanning 140 miles. The Dike has been impacted by wind-driven waves and erosion-related seepage.

**Yellow line** indicates area of most concern, a 68-mile reach from Port Mayaca to Moore Haven.

**Red arrows** indicate direction of flow in rivers, creeks and canals.
